FAA R&D Contract No. DTFA03-02-C-00044
DESTRUCTIVE EVALUATION
AND EXTENDED FATIGUE TESTING
OF A RETIRED PASSENGER AIRCRAFT (B727)

Phase II, CLIN 0002(d), Task 9
Damage Characterization
Q4 Update

Ramesh Ramakrishnan
Principal Engineer - Enabling Technologies

10/29/03

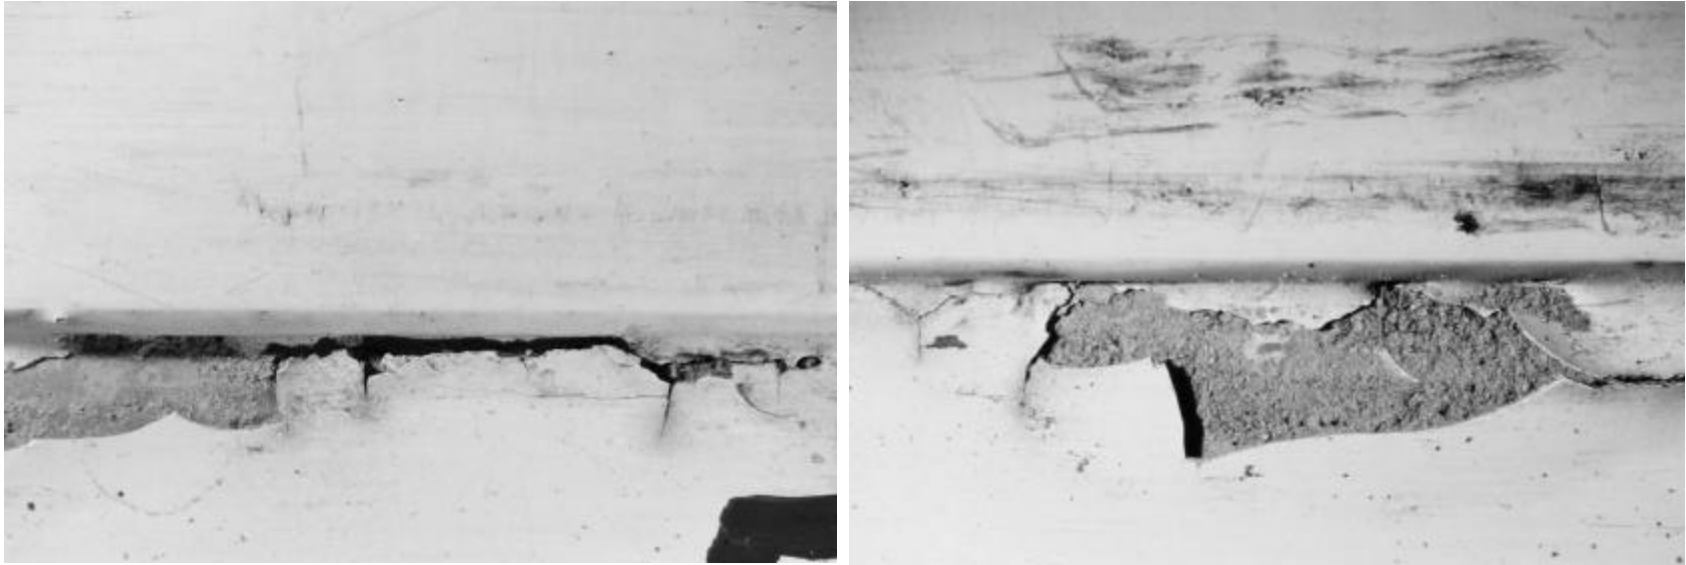
Lap joint bay at stringer 4R , FS 540 to 560, cut out from panel F3 for destructive characterization of all fastener holes in the joint. View looking outboard.

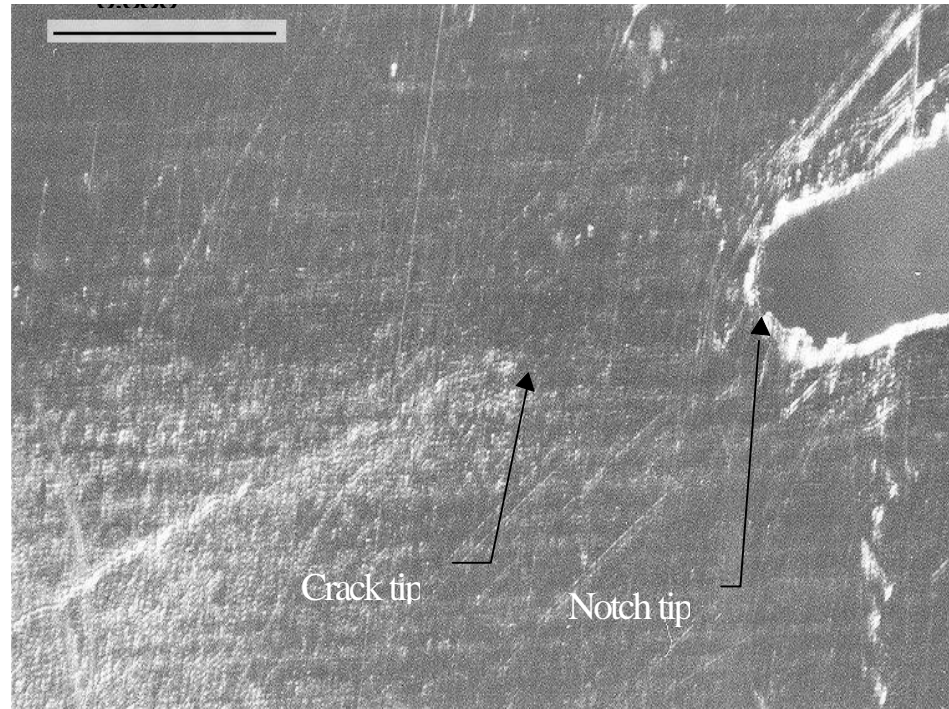
Another example: Hole #37 after rivet removal

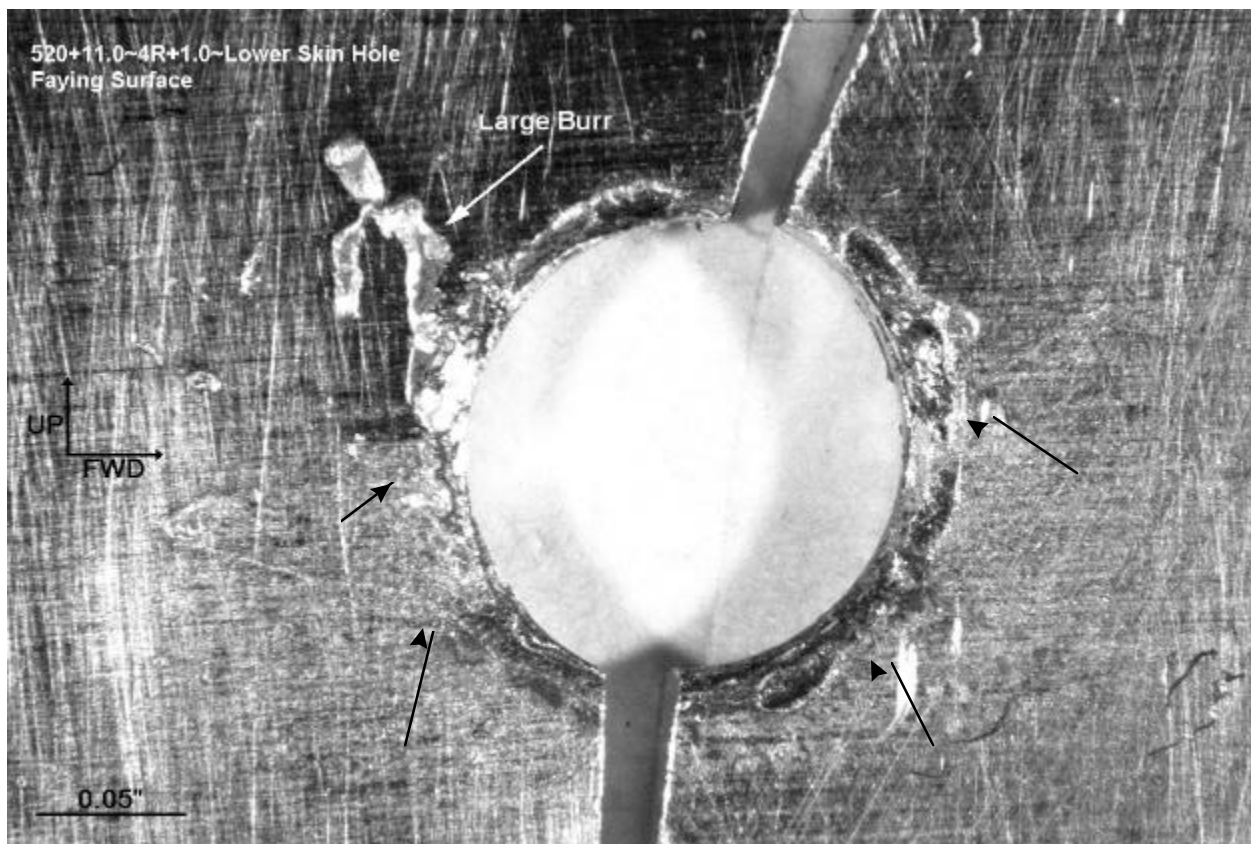
- Lower skin faying surface at hole location 520+11.0~4R+1.0~LSH

Note the presence of 4 cracks and fretted, gouged regions around the hole edge through which the cracks pass

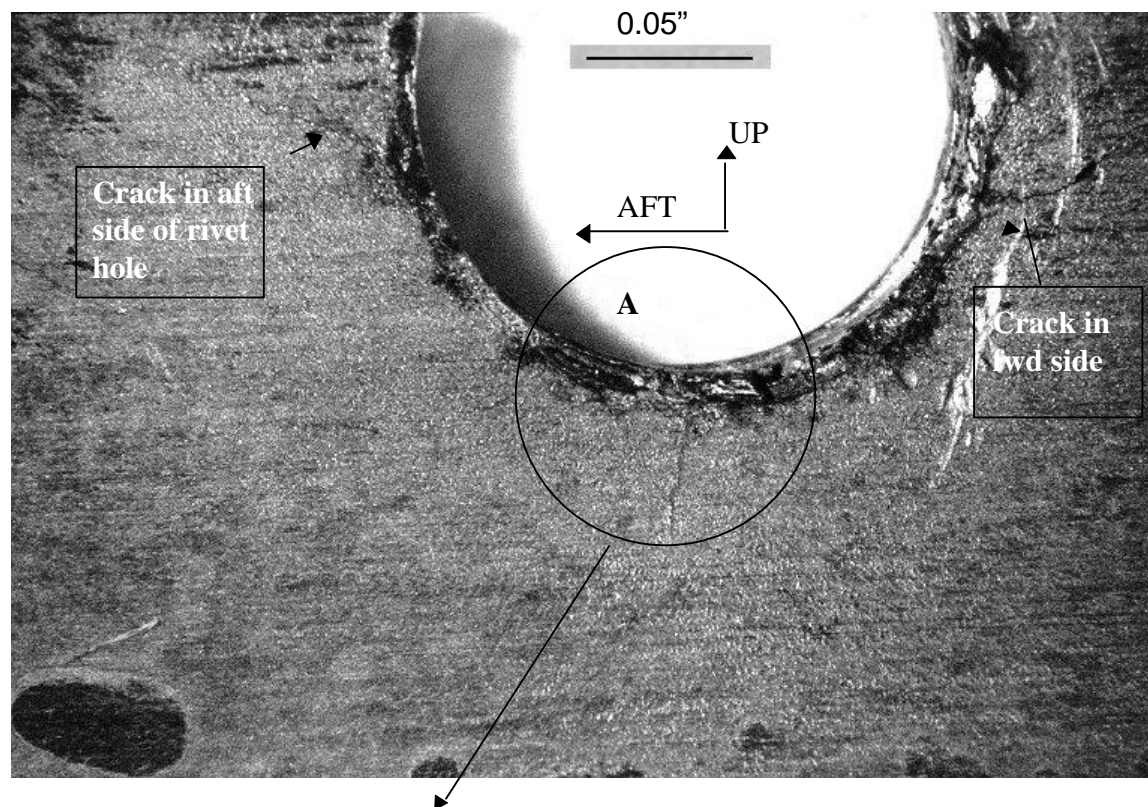
- Lower skin faying surface at hole location 540+06.8~4R+1.0~LSH

Note the regions of fretting and gouges/tool marks seen near the cracks

In addition to the two main cracks seen forward and aft of the rivet hole, there are at least 3 more cracks in this region running radially away from the hole.

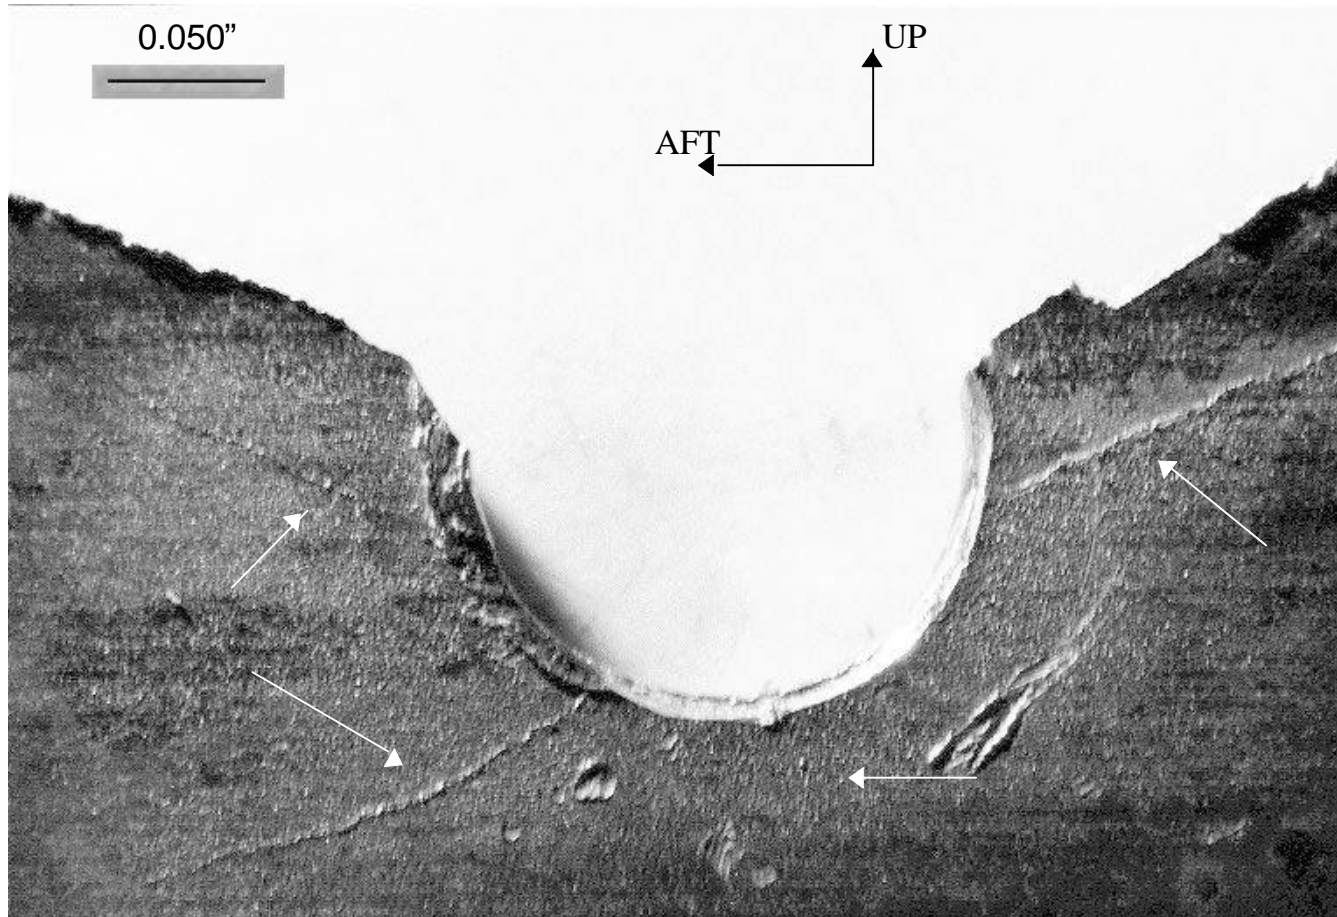
- Lower skin faying surface at hole location 540+07.9~4R+1.0~LSH

Faying surface of lower skin showing four cracks emanating from the hole as identified by arrows.

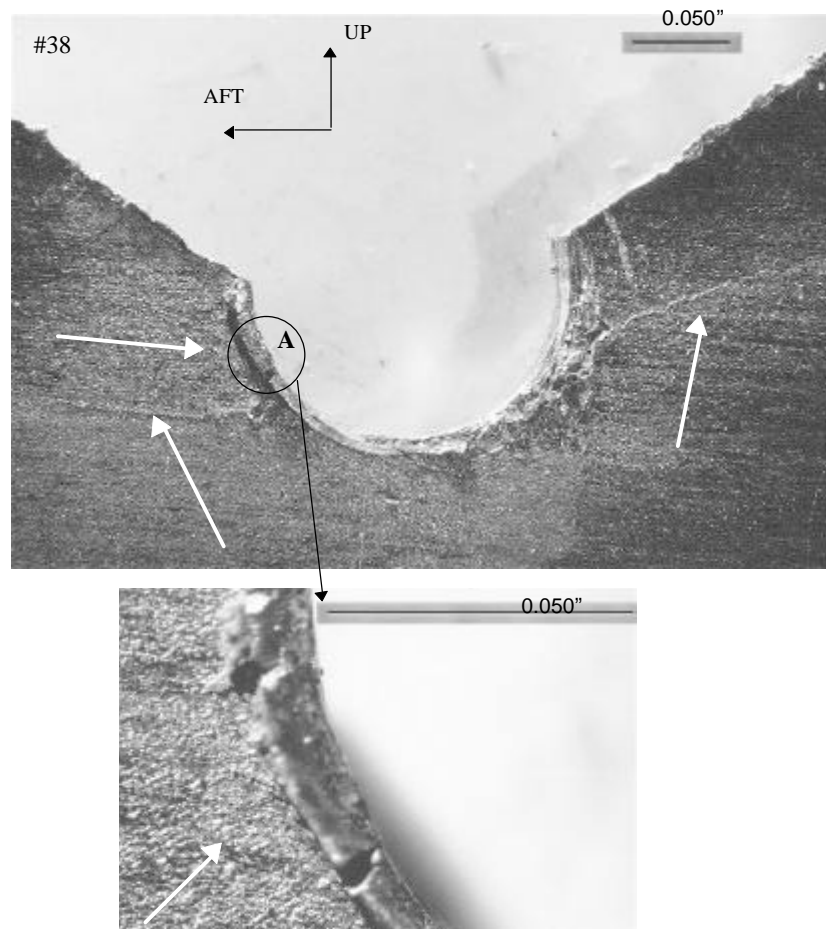
Lower skin faying surface at hole location 540+10.0~4R+1.0~LSH

Note the deformed lip at the hole edge where the cracks are located

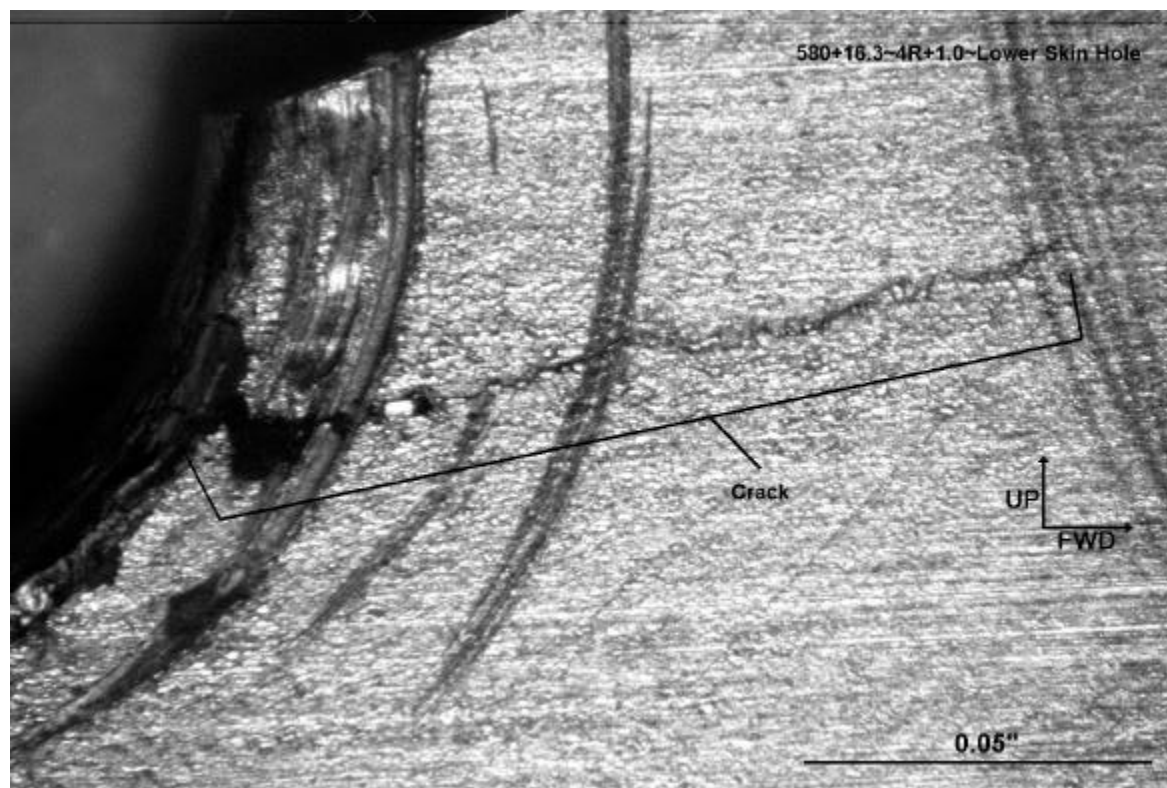
- Lower skin faying surface at hole location 580+16.3~4R+1.0~LSH

Note the deep gouges/tool marks through which the crack traverses.

Two more cracks were present at this hole but did not show up clearly in the micrographs

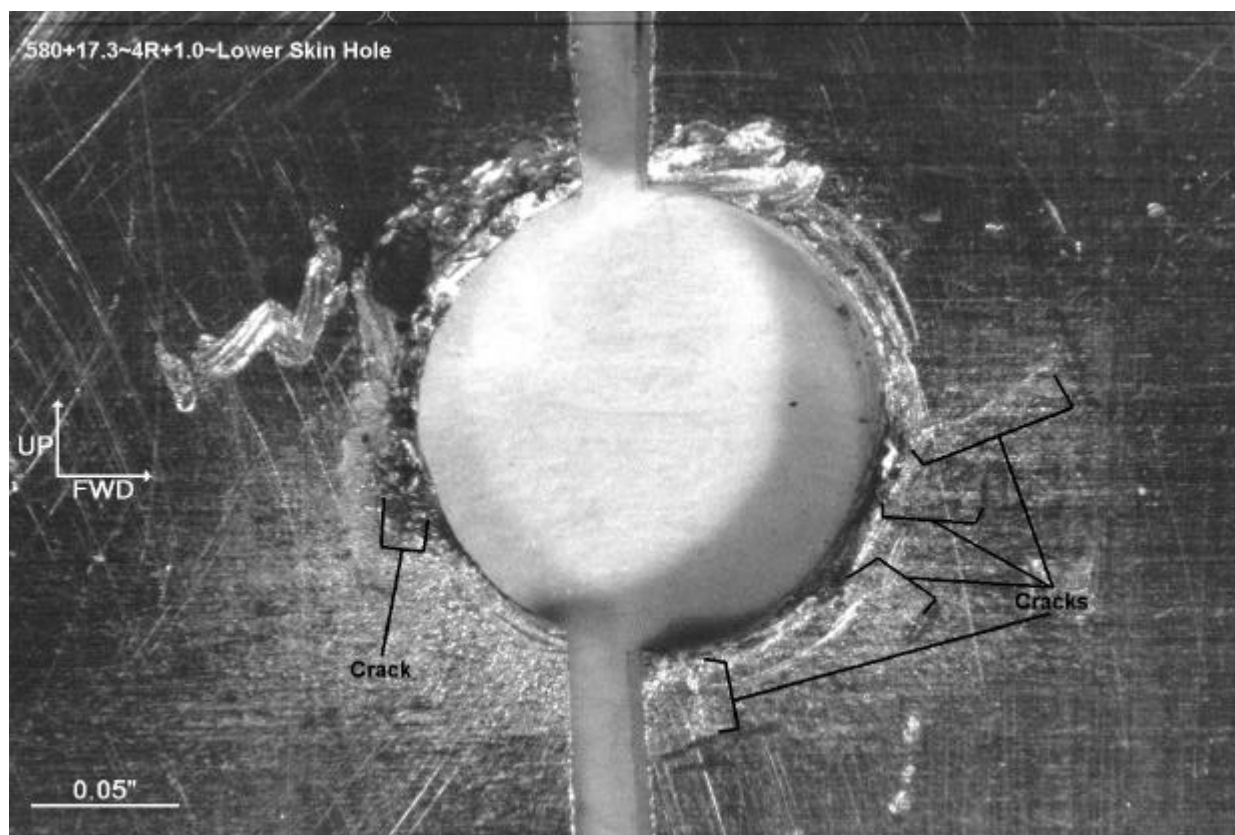
- Lower skin faying surface at hole location 580+17.3~4R+1.0~LSH

Note the deep gouges/tool marks present around the hole.

Five cracks were present at this hole as shown

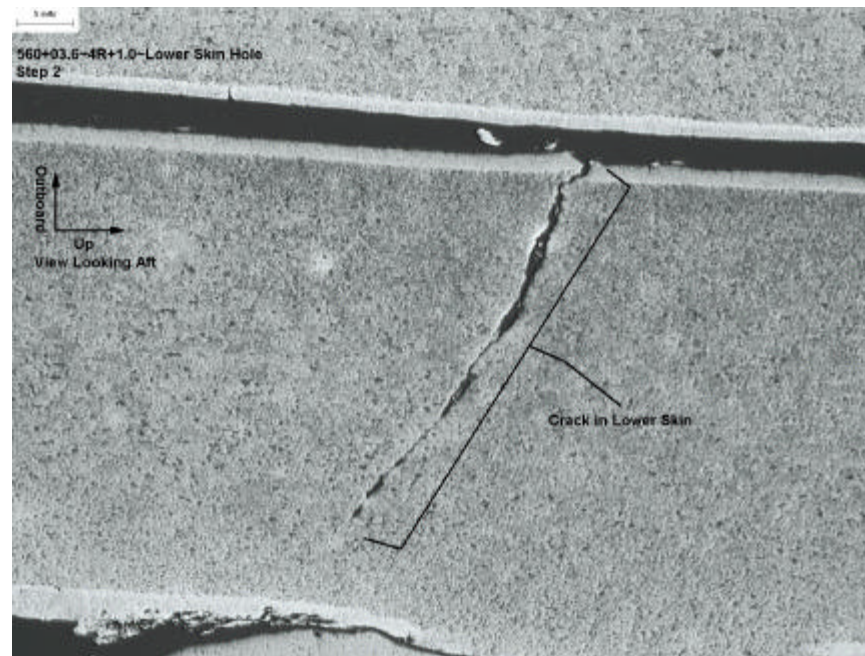
Cross sectional view of the lap joint coupon 560+3.6~4R+1 after initial sectioning and polishing.
Note the presence of a crack in the lower skin which was not evident on the inboard surface.

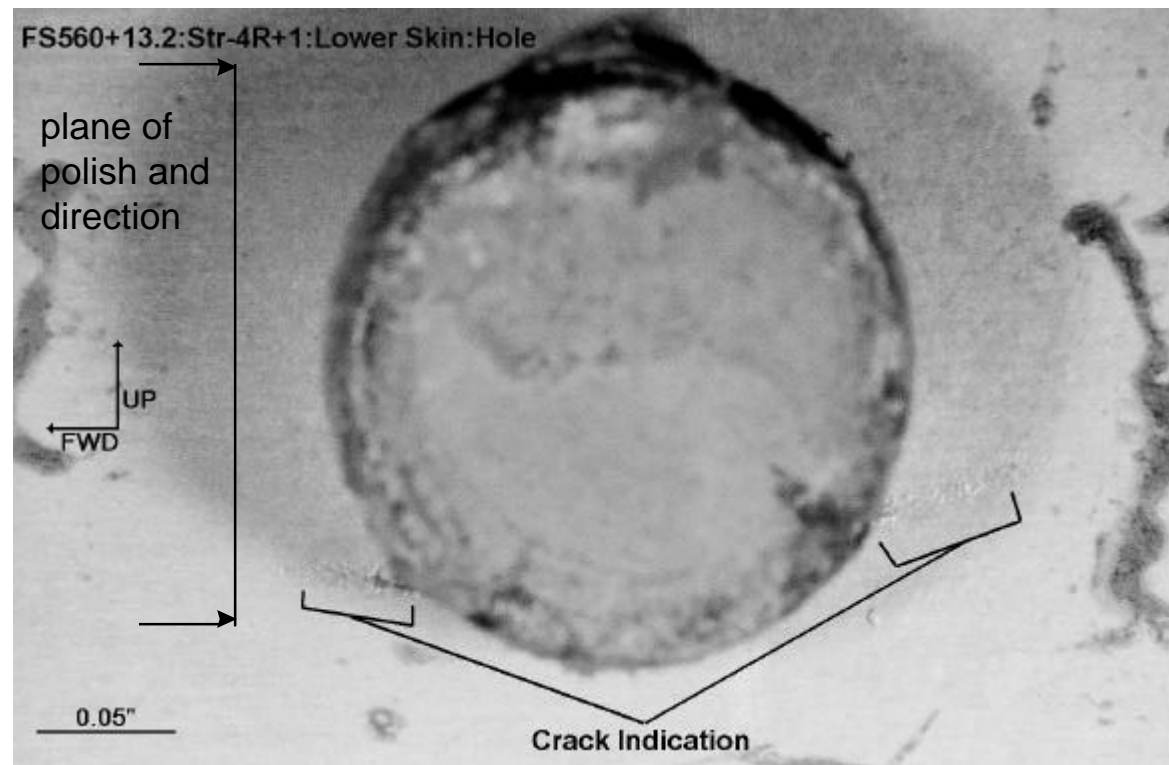
- Normal view of third lap joint coupon at location 560+13.2~4R+1.0~LSH with the rivet still installed. This coupon was polished down as shown, with the section plane as defined.

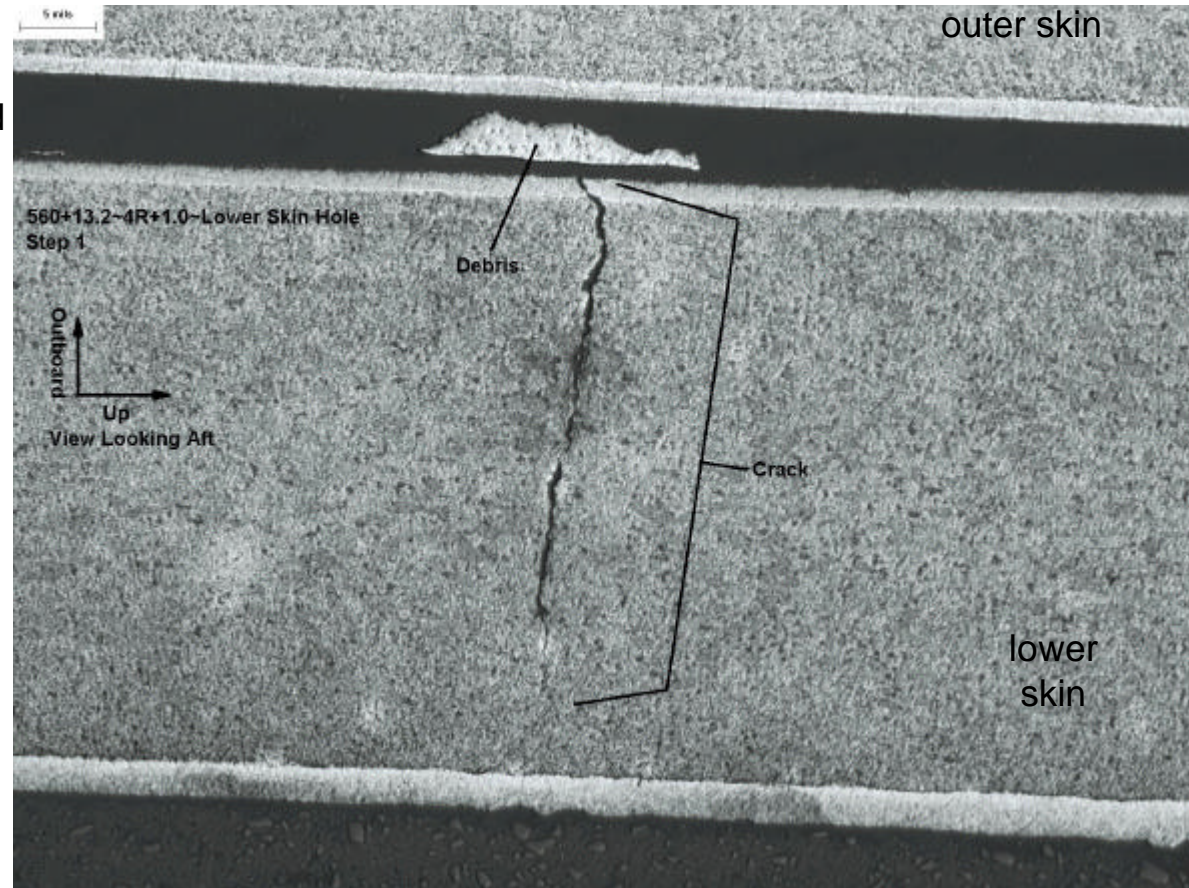
- Sectional view of third lap joint coupon at location 560+13.2~4R+1.0~LSH - initial section outside the rivet showing the crack in the lower skin

Note the presence of metal debris between the lower and outer skins' faying surfaces and directly above the crack

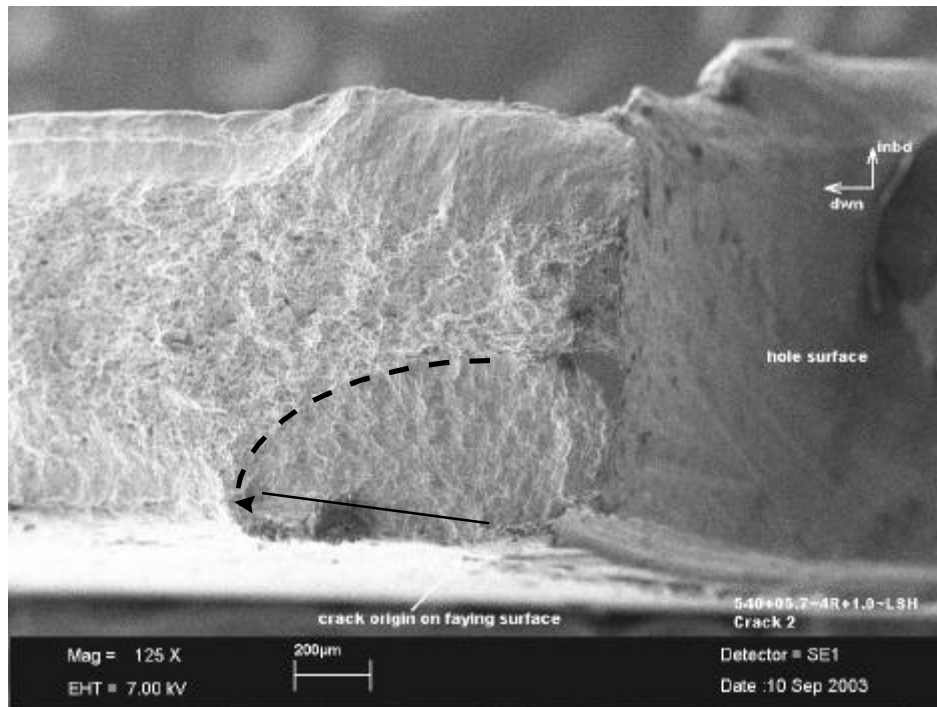
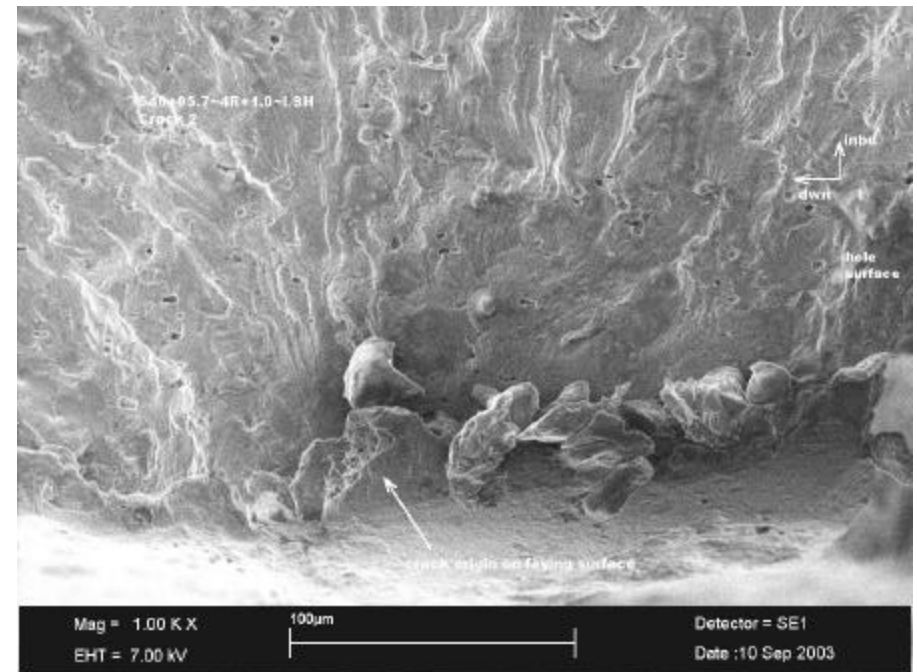
Crack #2 and origin at fastener hole location 540+05.7~4R+1.0~LSH

Note the groove present along the hole edge at the skins' faying surface

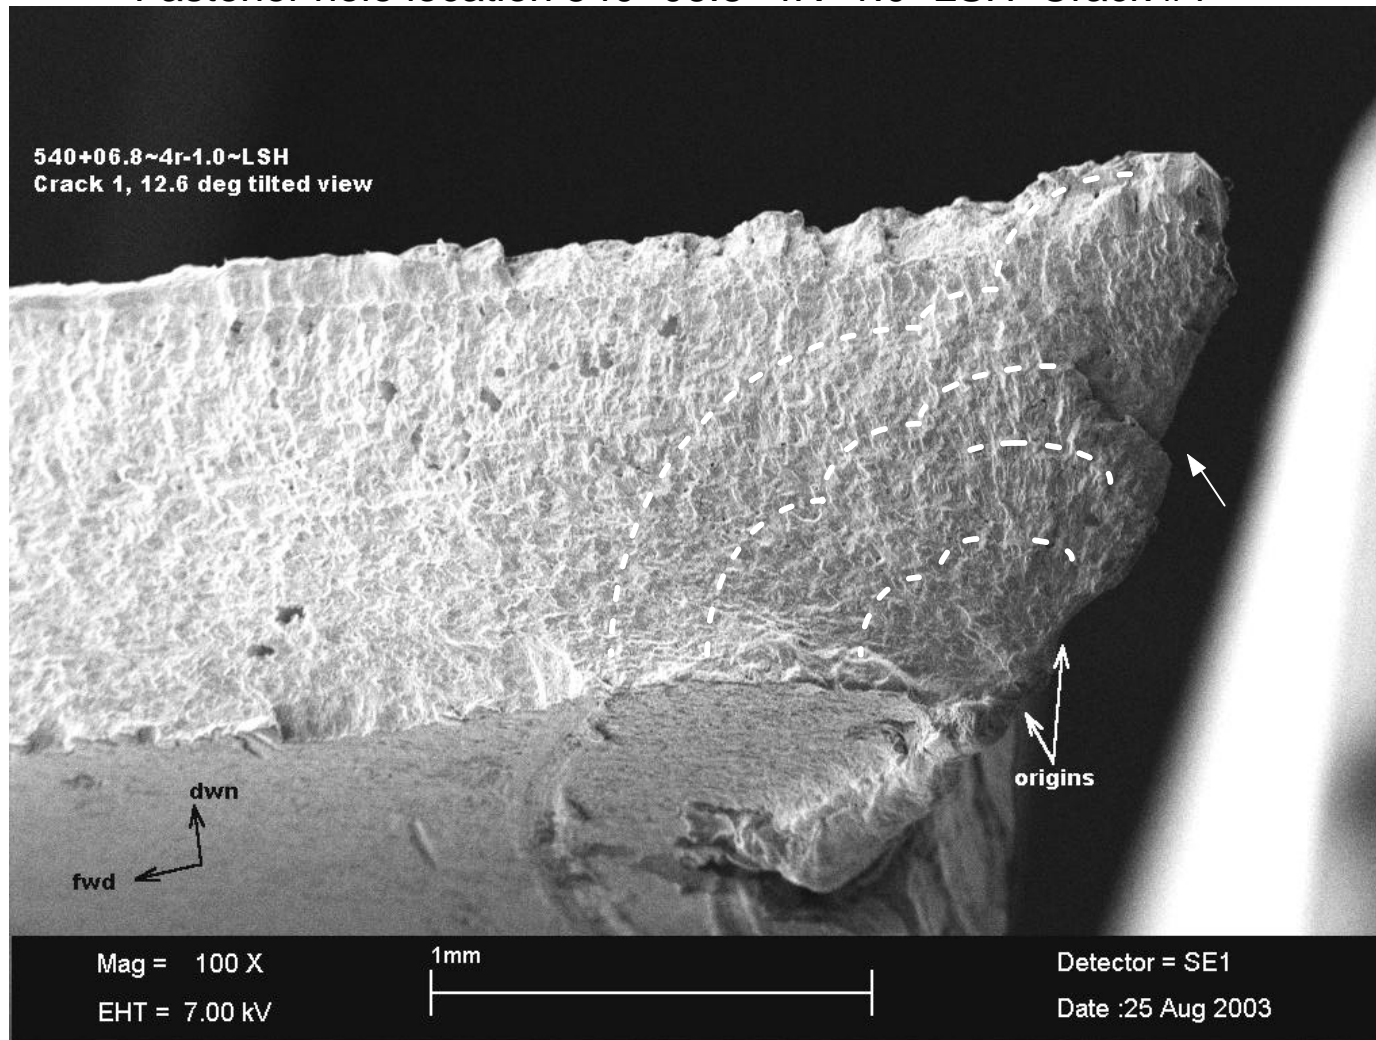
Fastener hole location 540+06.8~4R+1.0~LSH Crack #1

Tilted view of Crack 1, showing the approximate progression of the crack fronts from the multiple origins, during the early stages of crack growth. The main origin appears to be adjacent to the deformed region at the hole corner

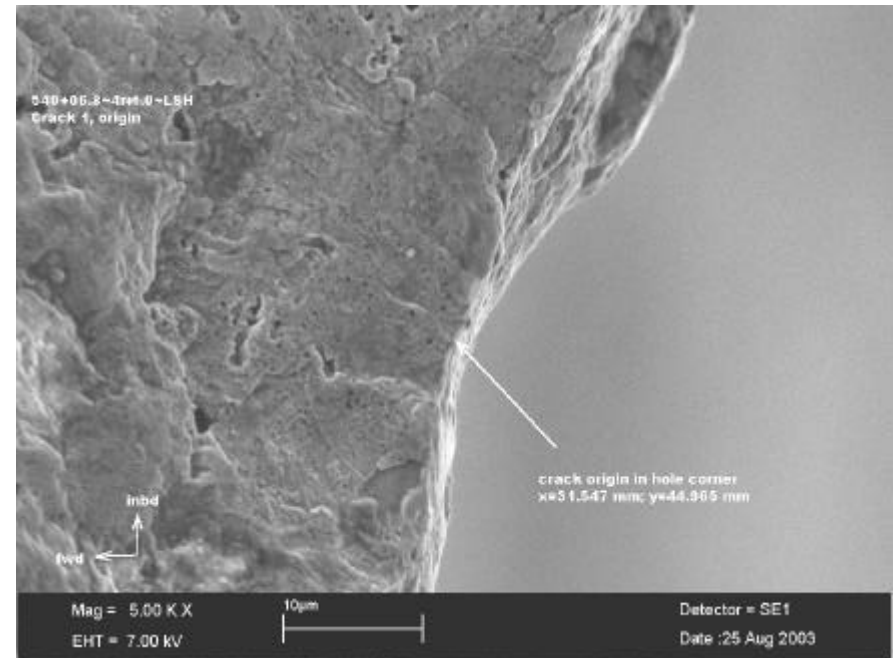
Fastener hole location 540+06.8~4R+1.0~LSH Crack #1 - Origins

Magnified views of the origins of crack 1 located at the hole corner

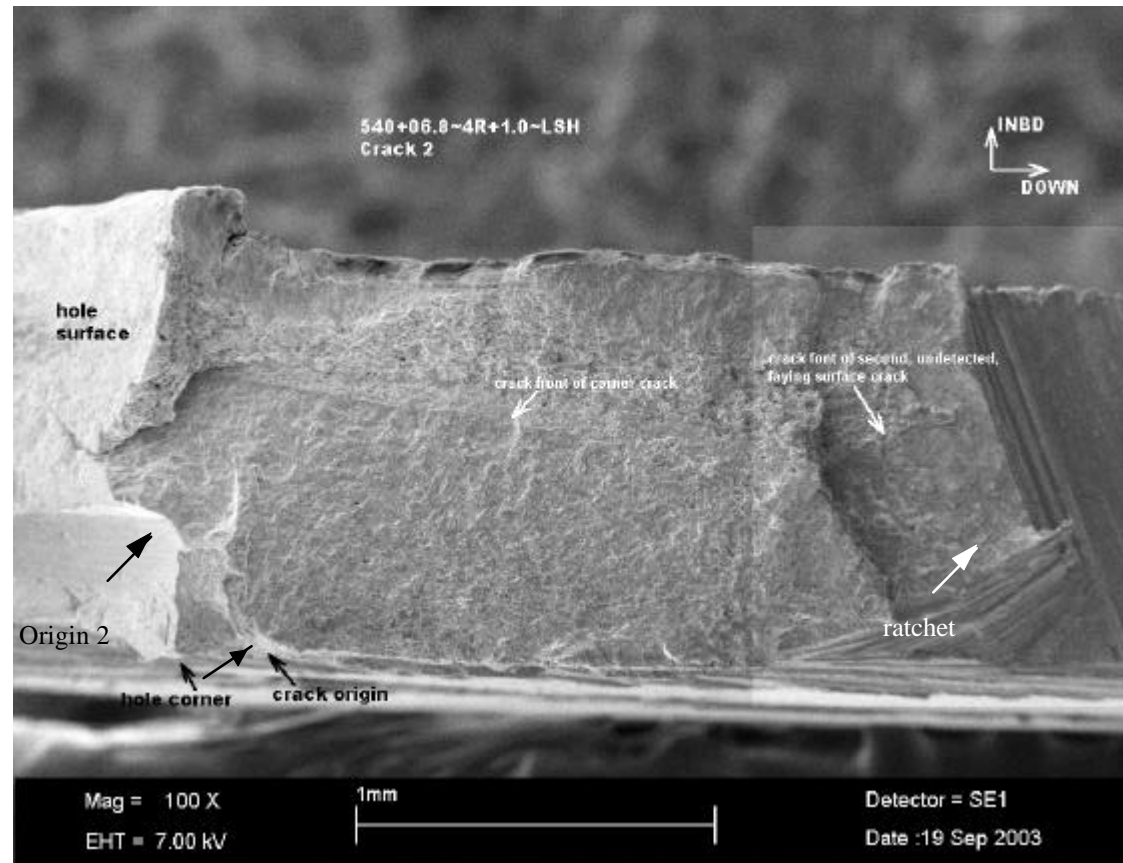
Fastener hole location 540+06.8~4R+1.0~LSH Crack #2

This micrograph shows the presence of two apparently independent cracks, one out of the hole and the other further out on the faying surface, that linked up at the ratchet mark (shear step) identified above. The crack out of the hole had a major origin at the hole corner and a second origin in the inside corner of a machining groove. The origin of the second crack on the faying surface was lost as this crack was not detected under stereomicroscope prior to introducing the saw cut to break open the crack. Striation count measurements have not yet been performed on this crack.

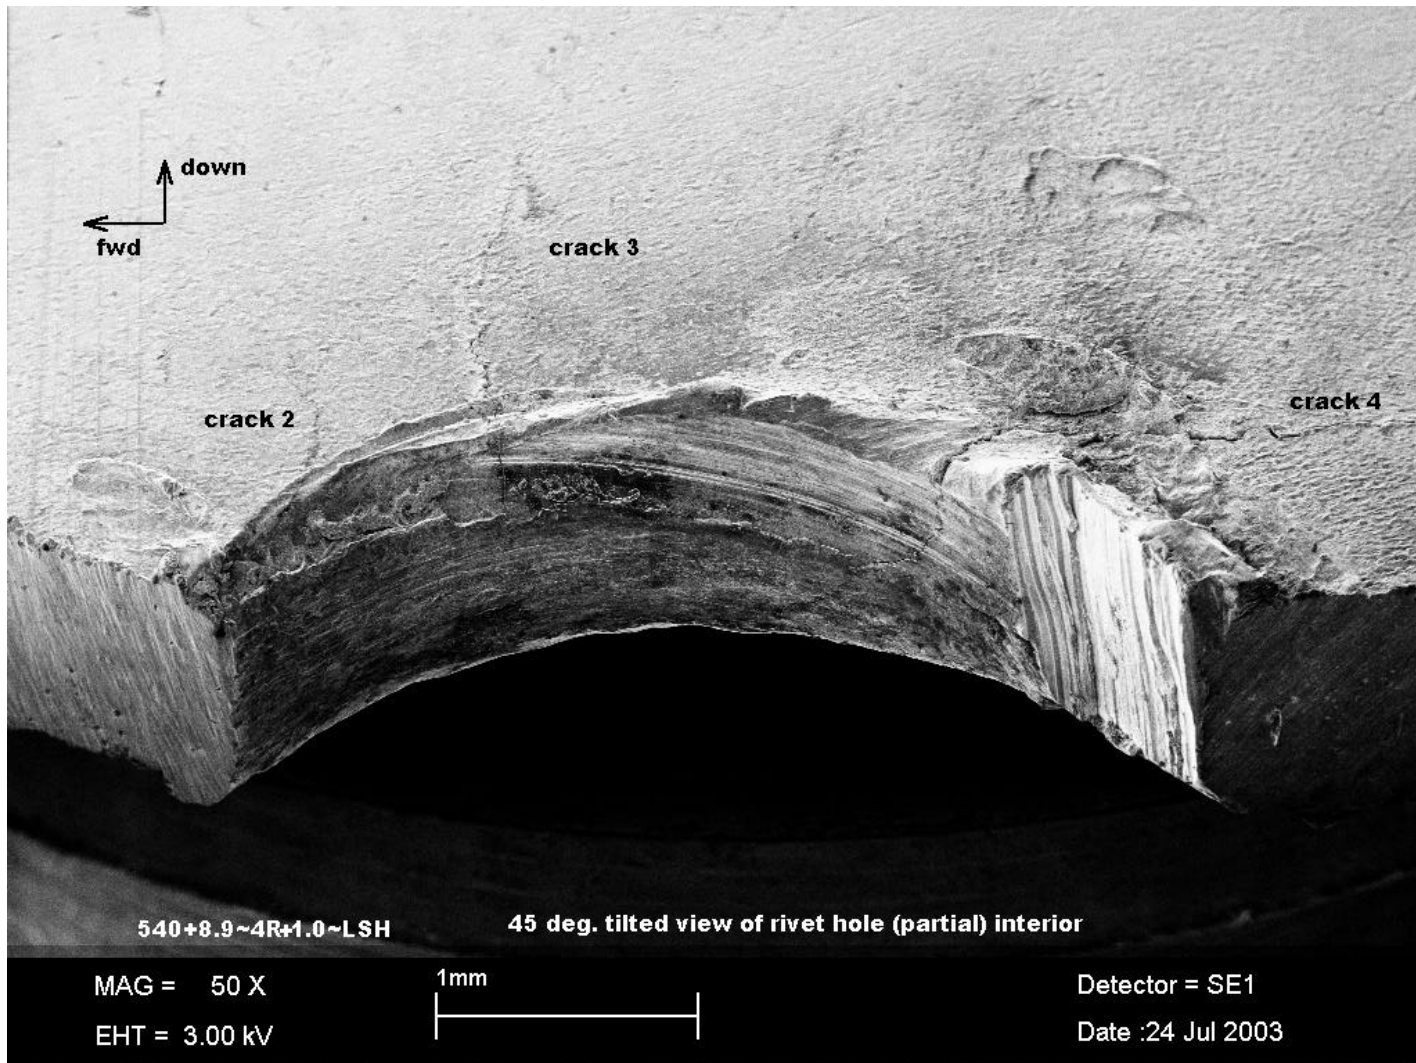
Cracks at fastener hole location 540+08.9~4R+1.0~LSH

Note that crack 1 had already been excised out of the hole and is not shown
